WACR Bridge 501 – T.S. IRENE Emergency Repairs

1. Overview of Interesting and Challenging ER Project
2. Slide Show With More Detailed Photography and Geeky Engineering / Construction Photos

Washington County Railroad (WACR)

Connecticut River Subdivision Bridge 501

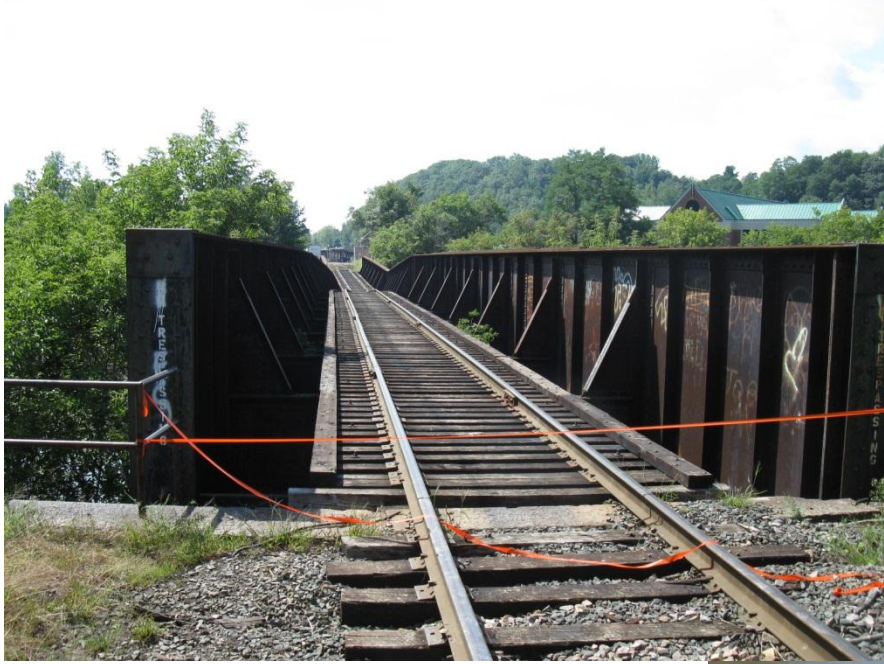
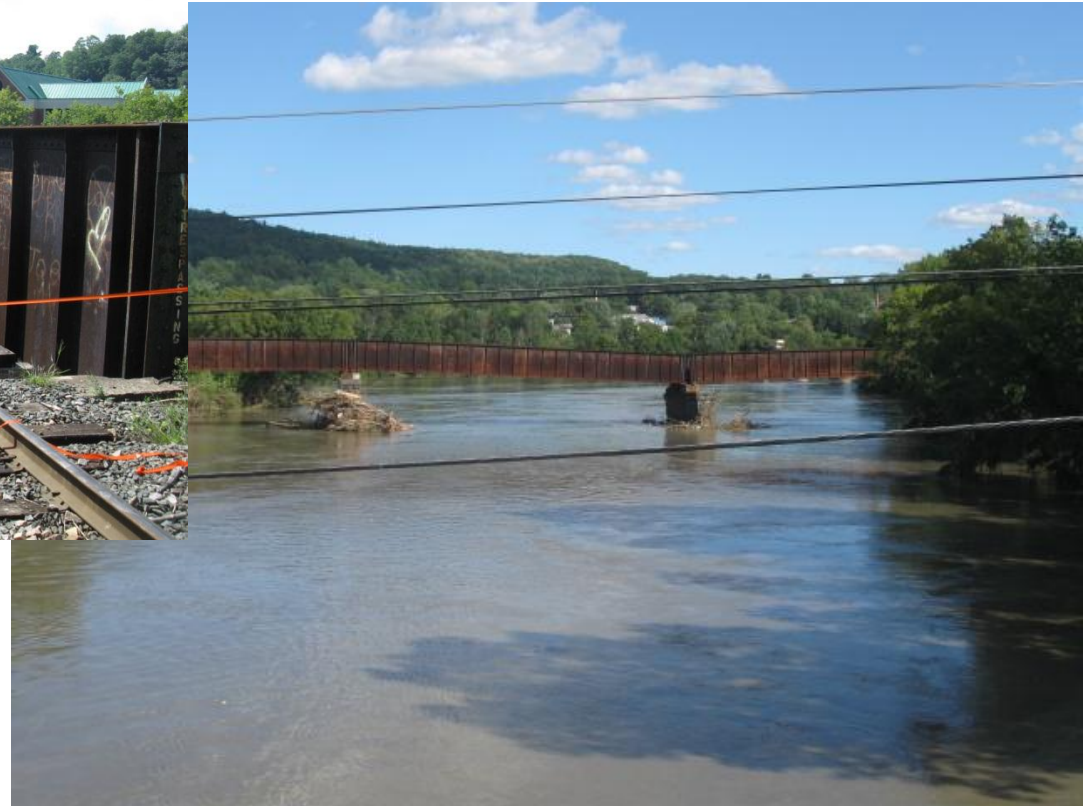
Heavy Debris Loading Resulted in the Severe Undermining of the South Pier

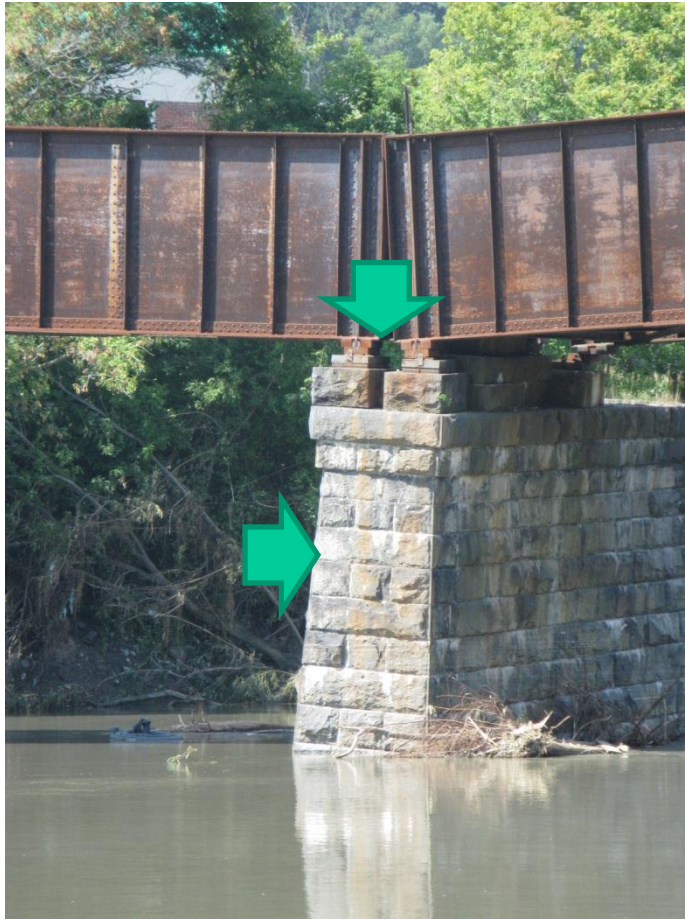
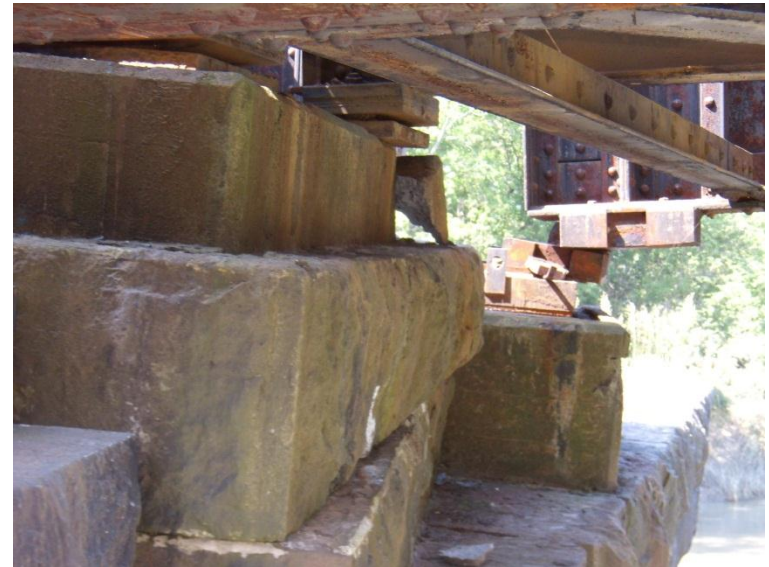
The pier settled nearly six feet and listed upstream nearly five feet. The middle span of the structure nearly slipped off the pier and into the river.

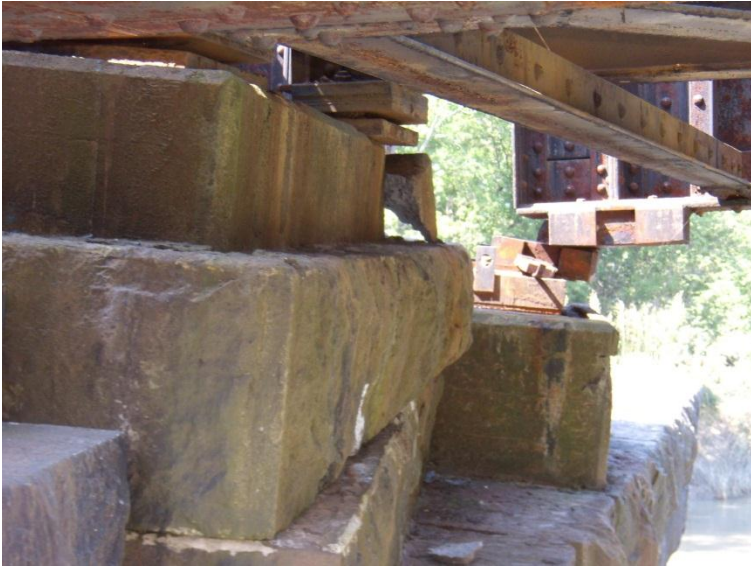
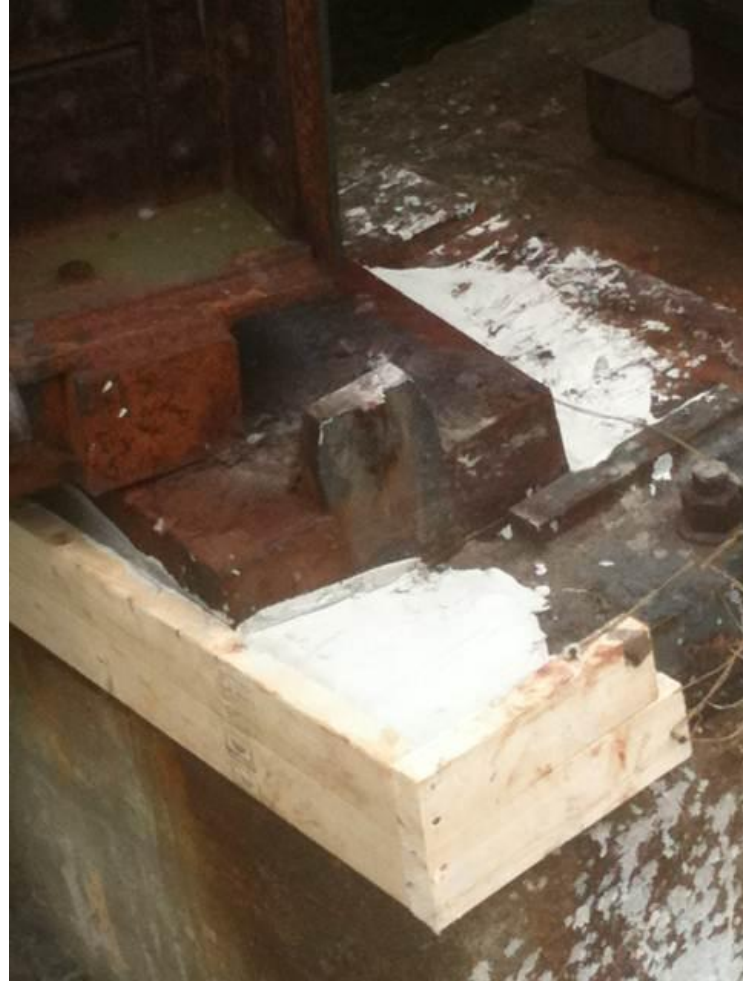
Extended Bearing Pedestal

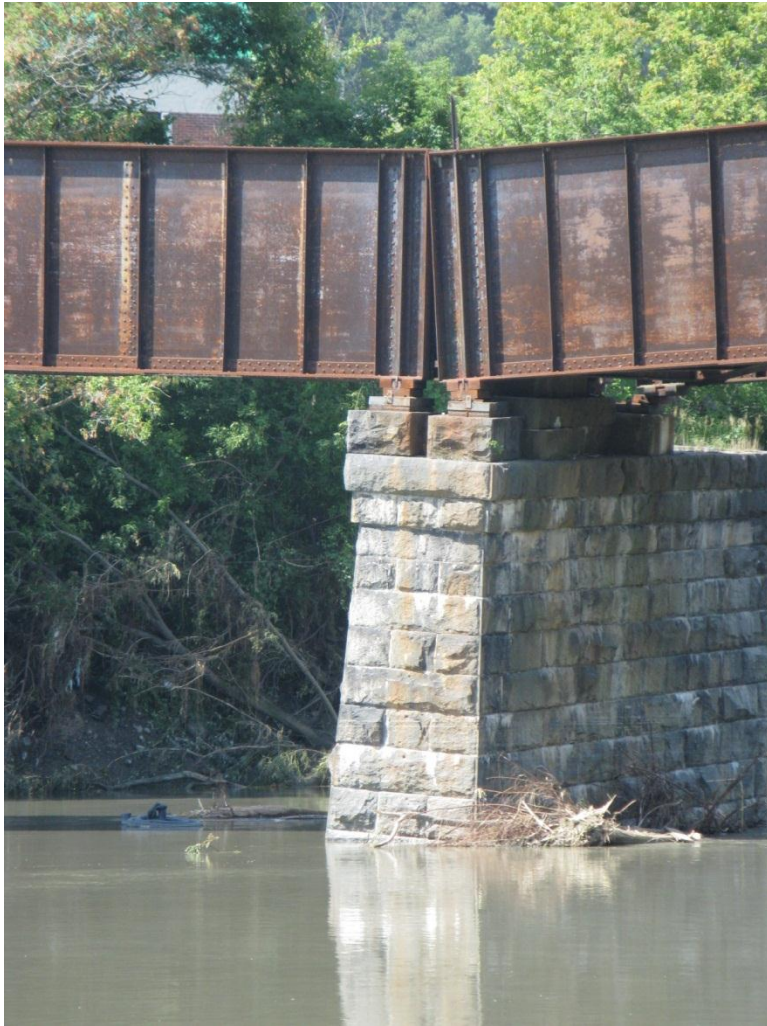
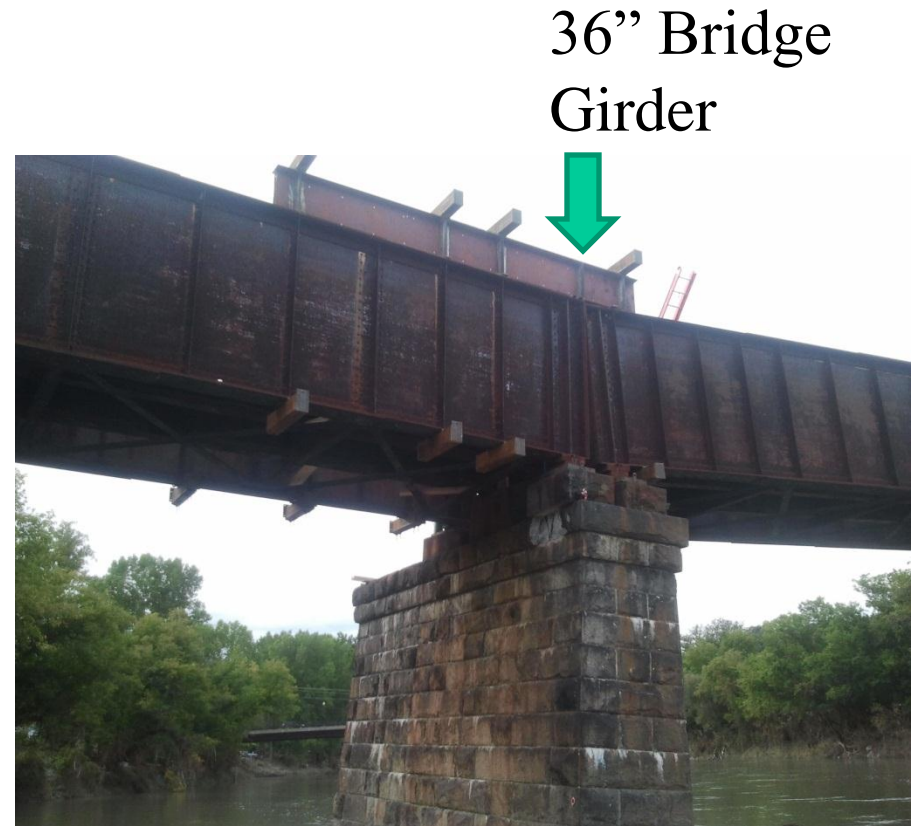
Splice Beams With Strongback

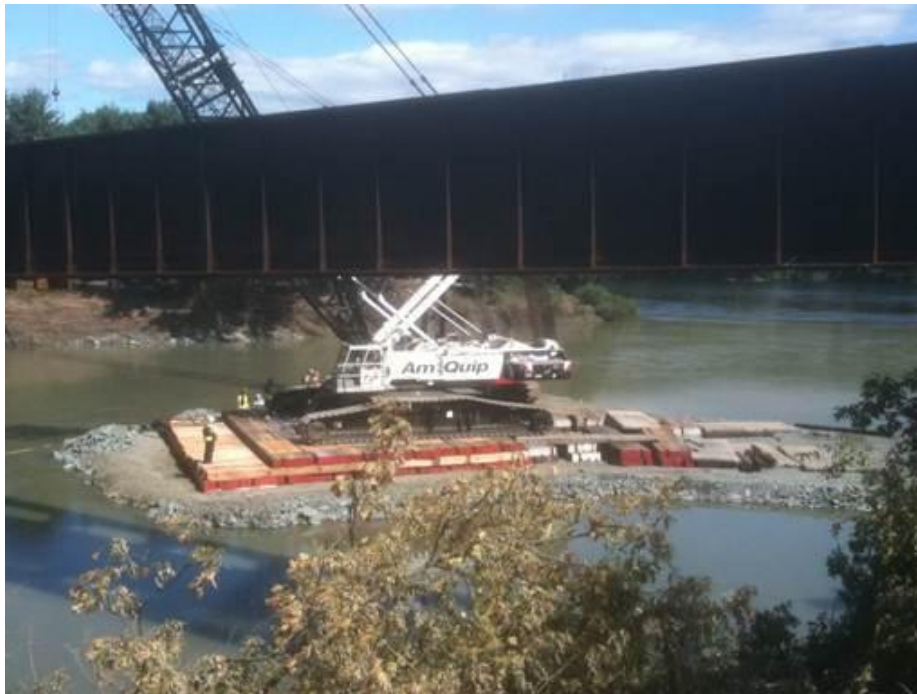
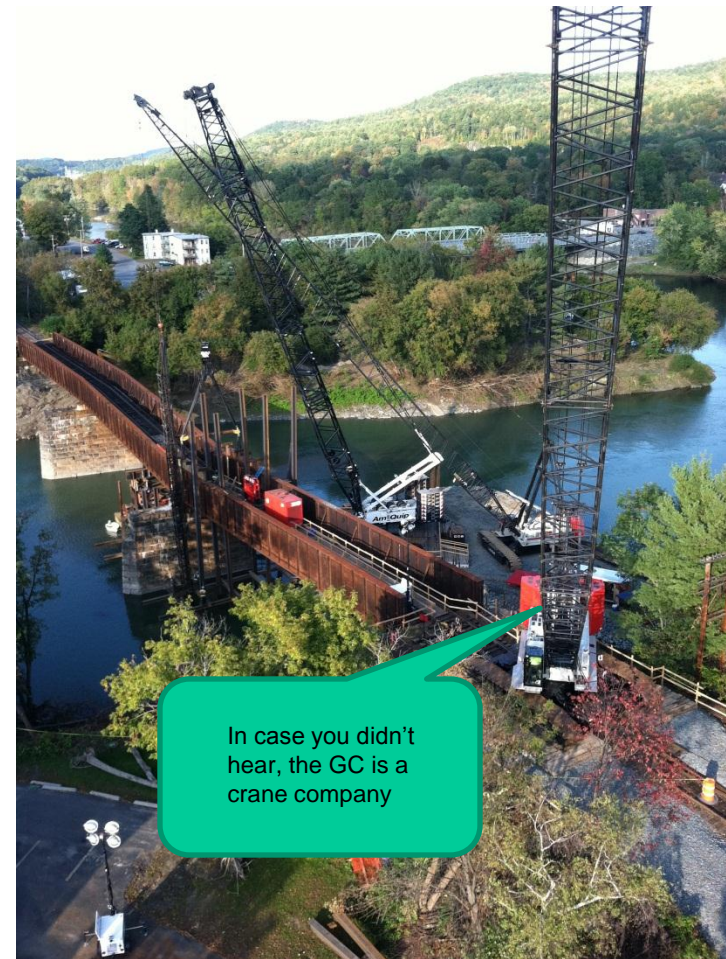
Backfill Scour Holes with Stone

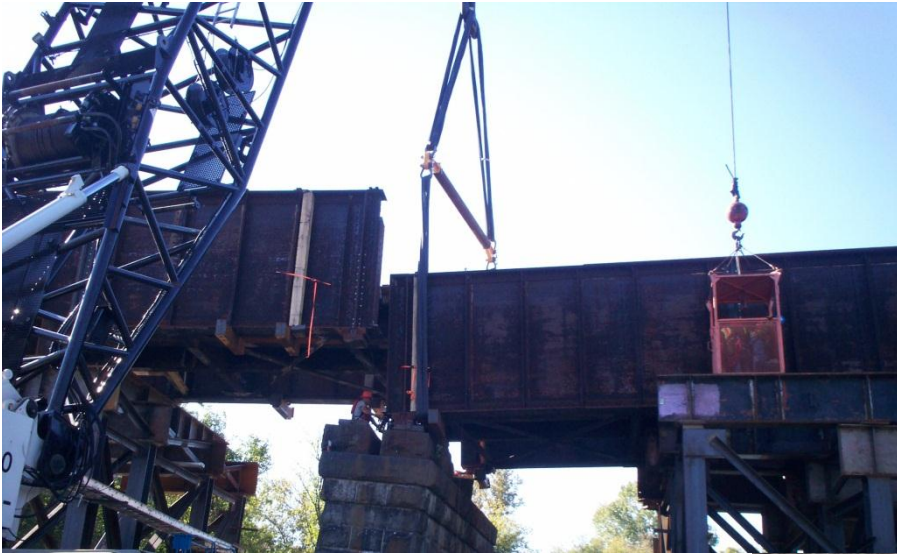
- Must accommodate current and restored position

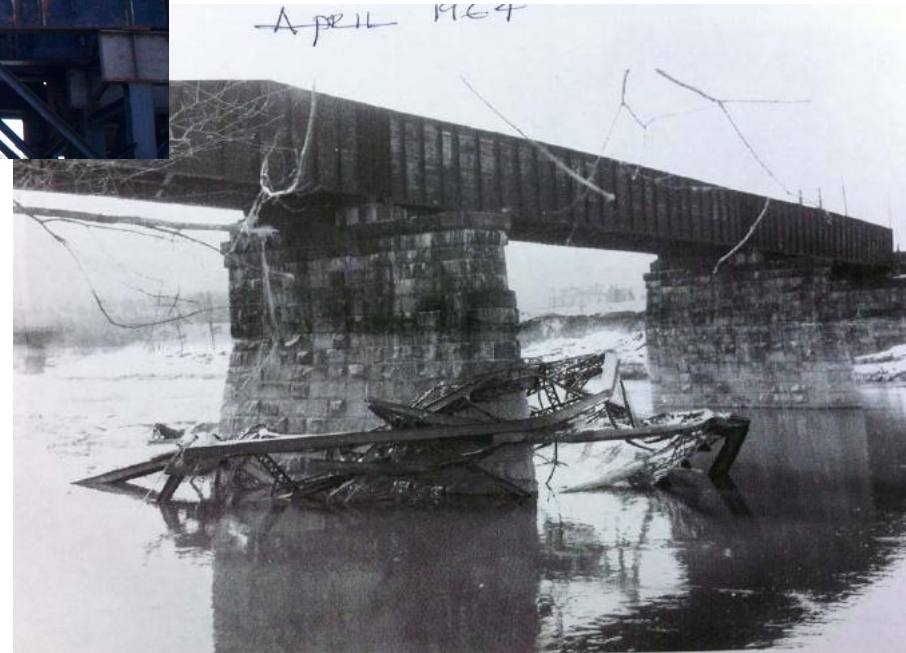
- Adjust design to avoid obstructions

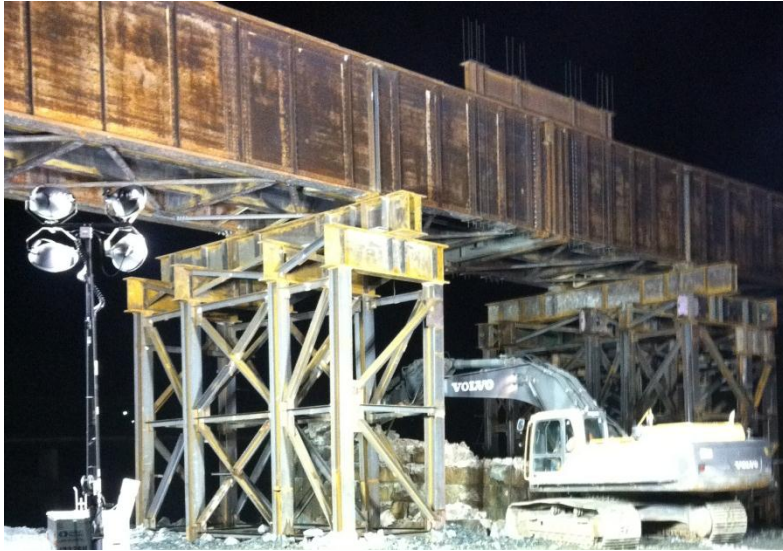
Shored Bridge to Cantilever Over Damaged Pier

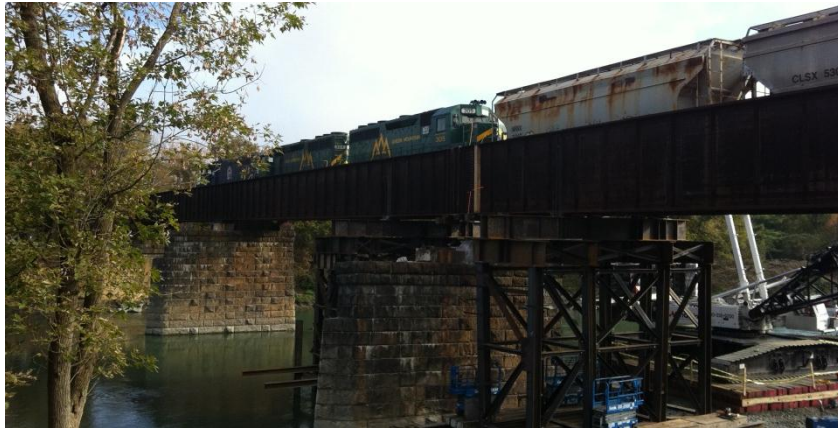
Hinged Cantilever Trains Running 42 Days After Response

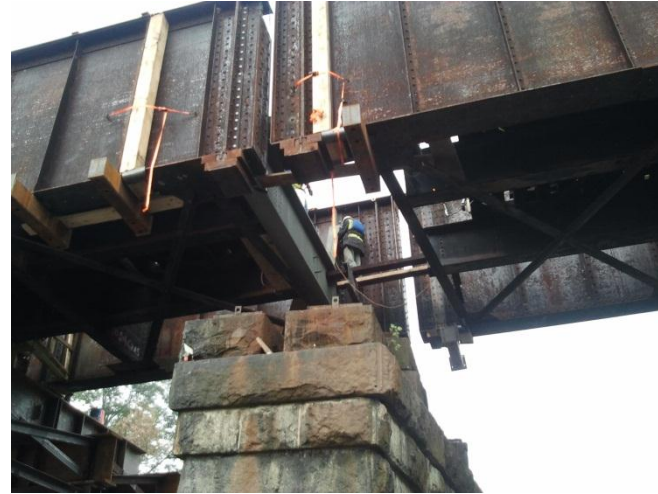
New Floor Beams – Easy Design, Tight Fab. Schedule (9/17-9/26) Required Increased coordination

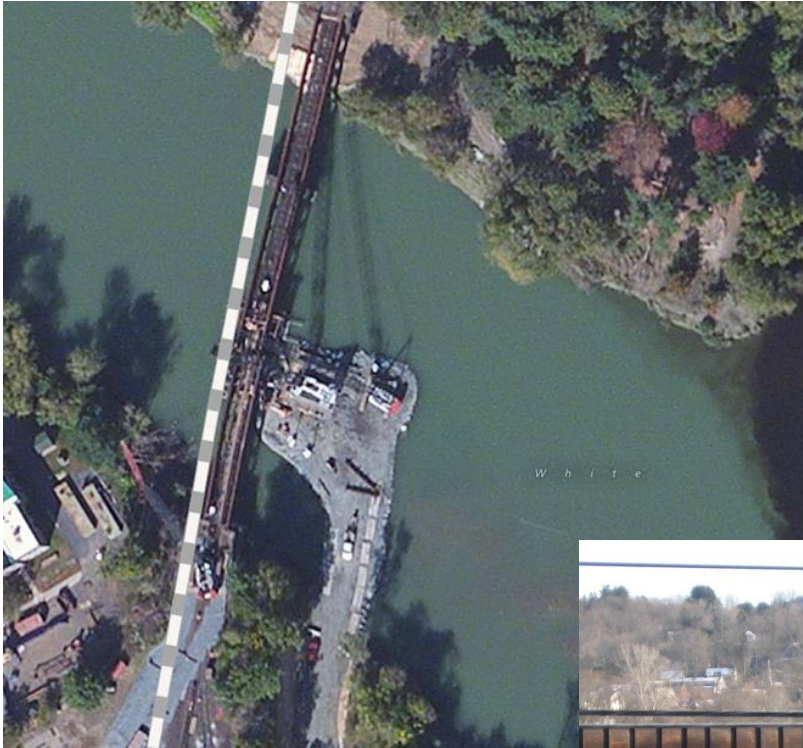
Due to massive footprint of access and risk due to ice, the decision was made to proceed with replacement vs. pull out for winter

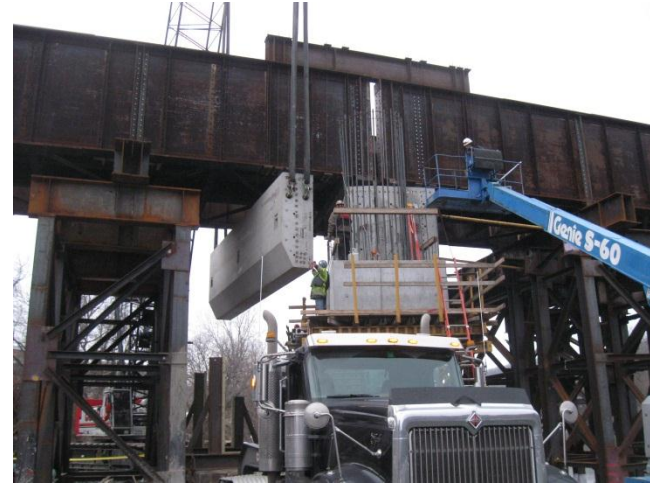
Precast Sandwich Beam Pier Cap (40 ton) – many details to coordinate
